# **Pentium® II Processor Specification Update**

Release Date: October 1997

Order Number: 243337-006

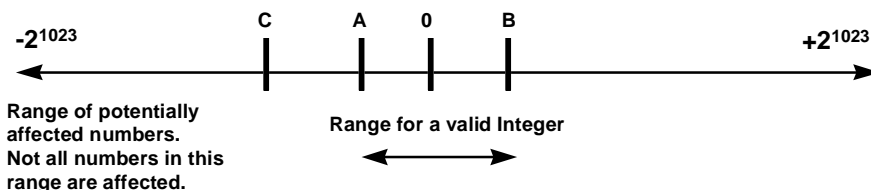
**IMPLICATION:** Erroneous operation results when the operand is so large that it will not fit into the target data size. The operands affected by this erratum are significantly outside (by a factor of 3X) the range that can be, correctly, converted to an integer value. The figure below and corresponding table identifies the normal range of integer numbers (between A and B) and the starting point of the operands affected by this erratum. Discrete failing operands will be present in the range between point C and the maximum negative number that can be represented by the processor ( $-2^{1023}$  in double precision format). Note 2 below gives a qualitative description of the nature of the discrete failing values. Software that does not rely on the Invalid Operation exception flag being set and signaled by either an exception OR by software polling is not impacted by this erratum.

16-bit Operation	A	B	C
	-32,768.0	+32,767.0	< -98304.0
32-bit Operation	A	B	C
	-2,147,483,648.0	+2,147,483,647.0	< -6,442,450,944.0

**WORKAROUND:** Any of two software workarounds will avoid occurrence of this erratum:

1. Range checking performed prior to execution of the FIST[P] instruction will prevent the overflow condition from occurring, and may already be implemented as a standard coding style.
2. Software can use the presence of MAXNEG in the result integer to indicate that an out of range conversion may have occurred.
